Failure Analysis

Lower Left Side Waterwall Tube Intermountain Power Project Unit 2

February 2006

SI Report E-05-327R

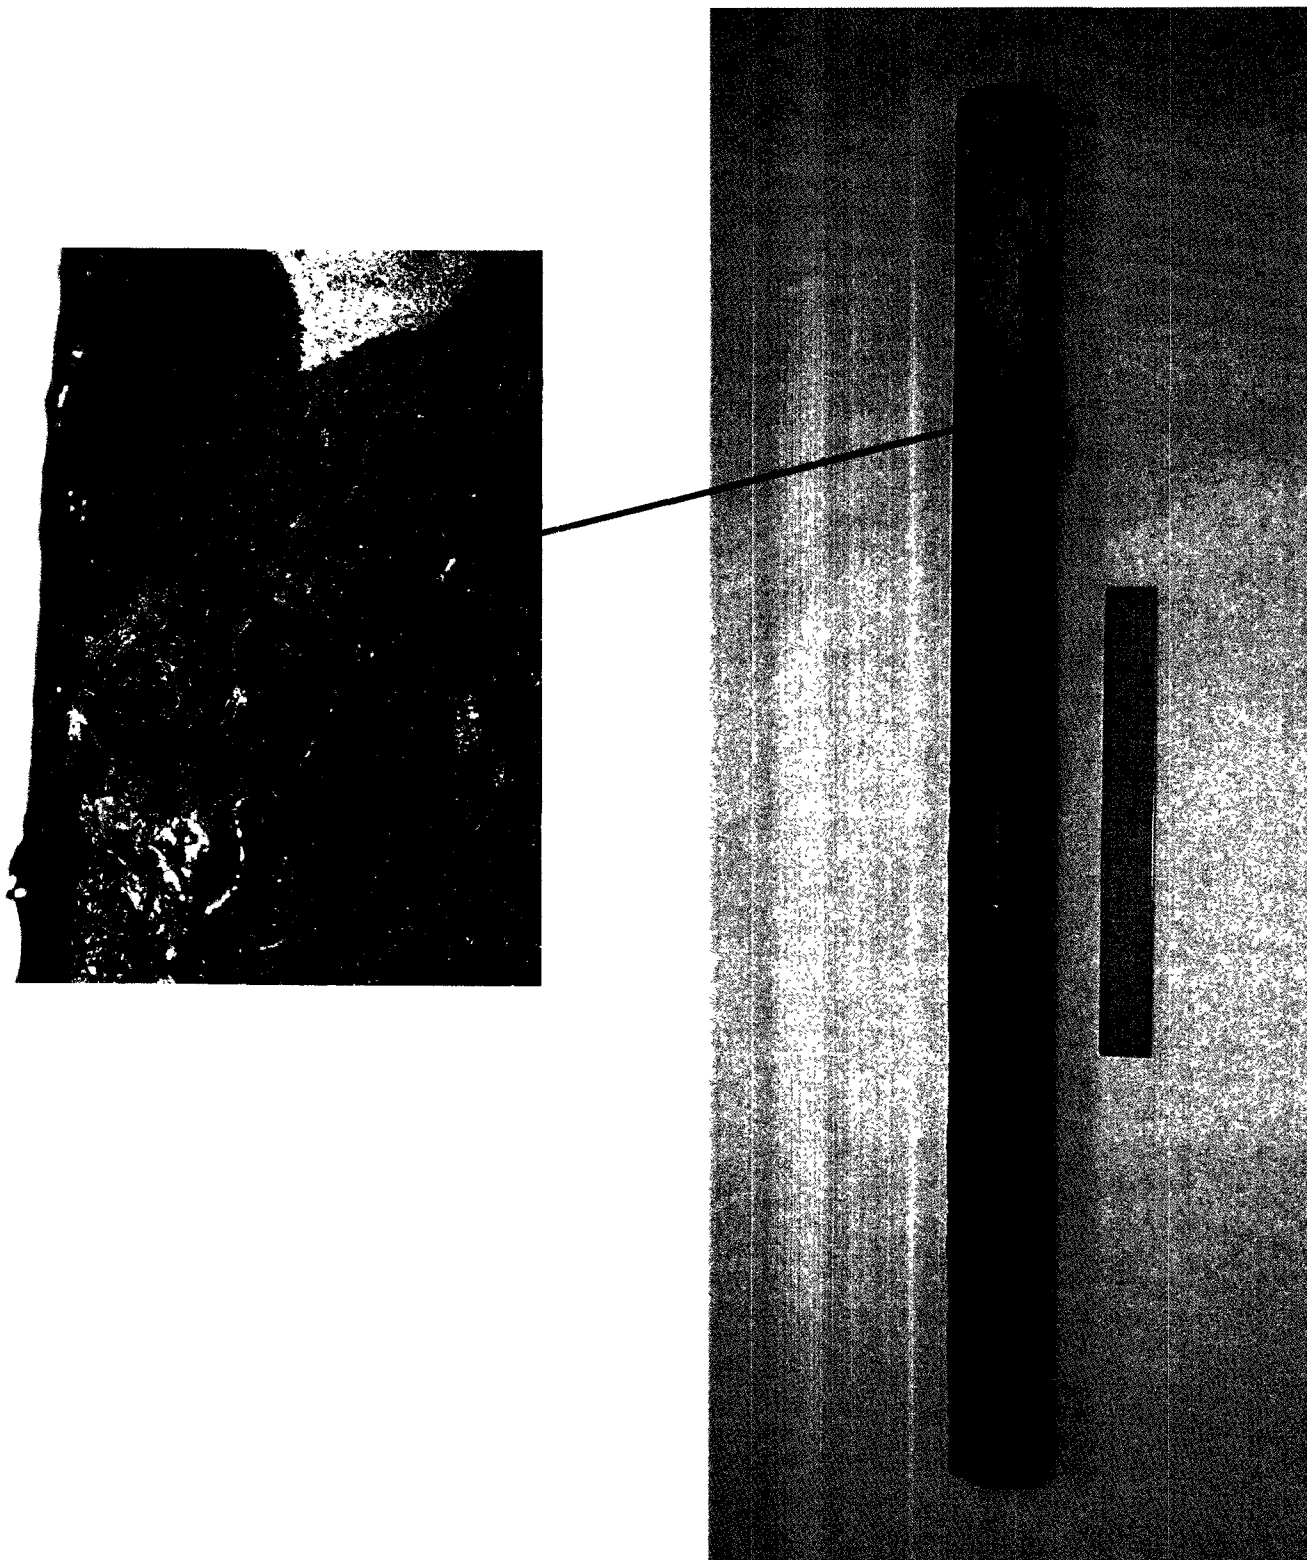
The waterwall tube section was visually examined and photographed in the as-received condition, as shown Figure 1. As shown in the close-up view within that figure, the leak was contained to a short crack located adjacent to an angled attachment weld. No significant swelling or other deformation was associated with the failure. In area adjacent to the rupture site, the external surface of the sample exhibited wall loss due to not only erosion/washing from the escaping fluid, but also severe wastage that occurred during the sample removal process. A portion of the tube containing the crack was longitudinally split to allow for an examination of the internal surfaces. As shown in Figure 2, the crack was shorter on the internal surface, indicating that the cracking likely initiated from the OD. The width of the opening and the orientation were similar on both surfaces.

Figure 1. The waterwall tube section (Element 180) shown in the as-received condition. A closer view of the failure site is shown to the left.

The cyclic stresses that have caused this tube to fail could also be causing similar cracking that is not as far advanced in other tubes. As a result, SI recommends that similar furnace sidewall and floor tubing be inspected to determine if other tubes are experiencing similar cracking.

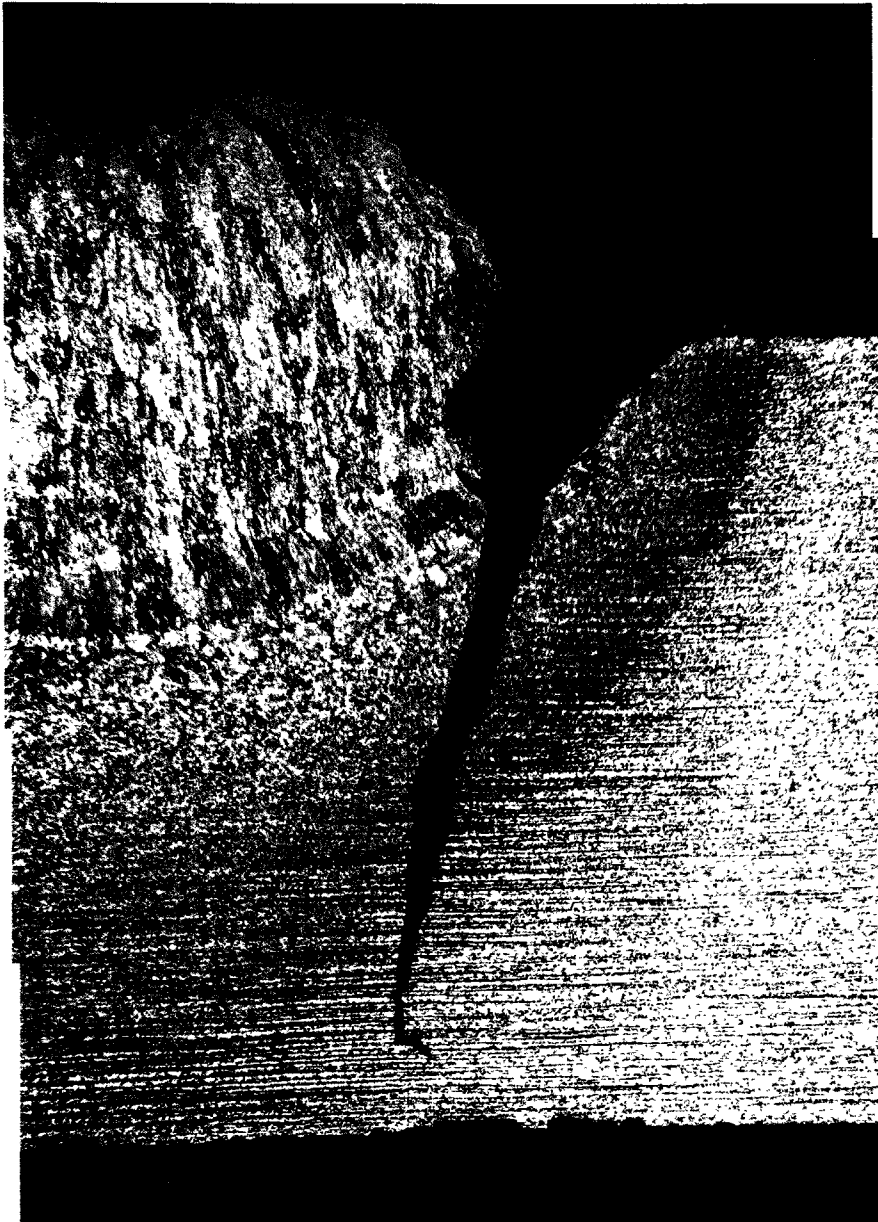
Two cross-sectional samples were removed from the failure location: along the center of the fracture where the crack was through the tube wall and towards the end, where the cracking had not propagated through-wall. The cross-sections were mounted and prepared for metallographic examination using standard laboratory techniques. A cross-sectional view of the crack where it did not propagate through the tube wall thickness is provided in Figure 3. As shown, it was apparent that the crack initiated from the external surface at the toe of the attachment weld. Higher magnification views of the crack tip are shown in Figure 4. The crack was relatively straight with no branching, and transgranular (through-grain), which are characteristic of cracking due to fatigue. The presence of high temperature oxide near the outer surface of the tube suggests that the tubing had operated for some time after the cracking had initiated. The shallow corrosion pitting along the fracture surface did not play a role in the failure.

Figure 3. A cross-sectional view of the waterwall tube, away from where the crack had propagated through the thickness of the element.

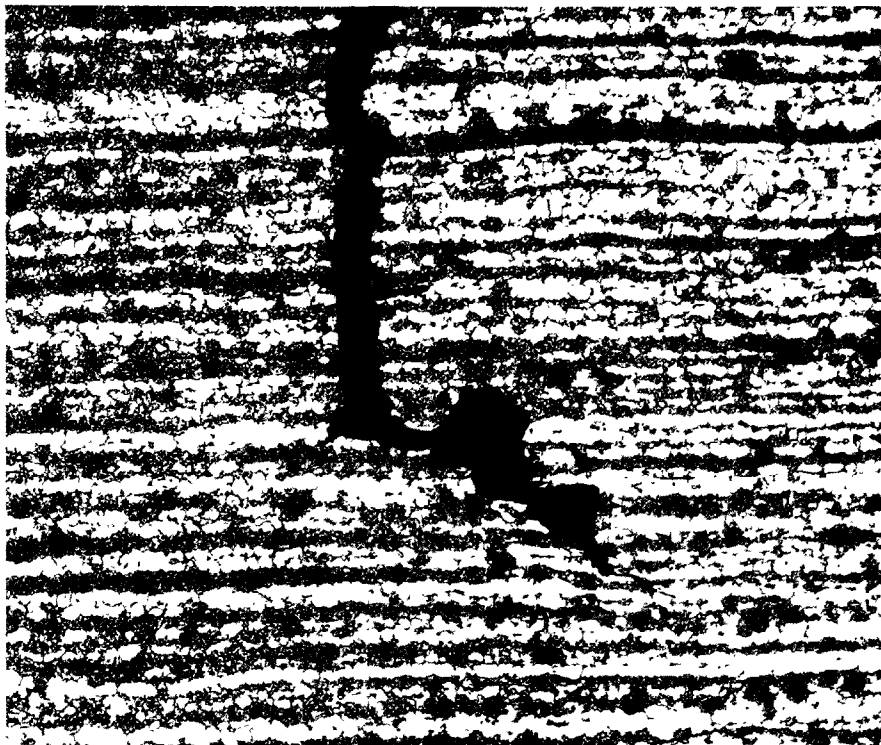
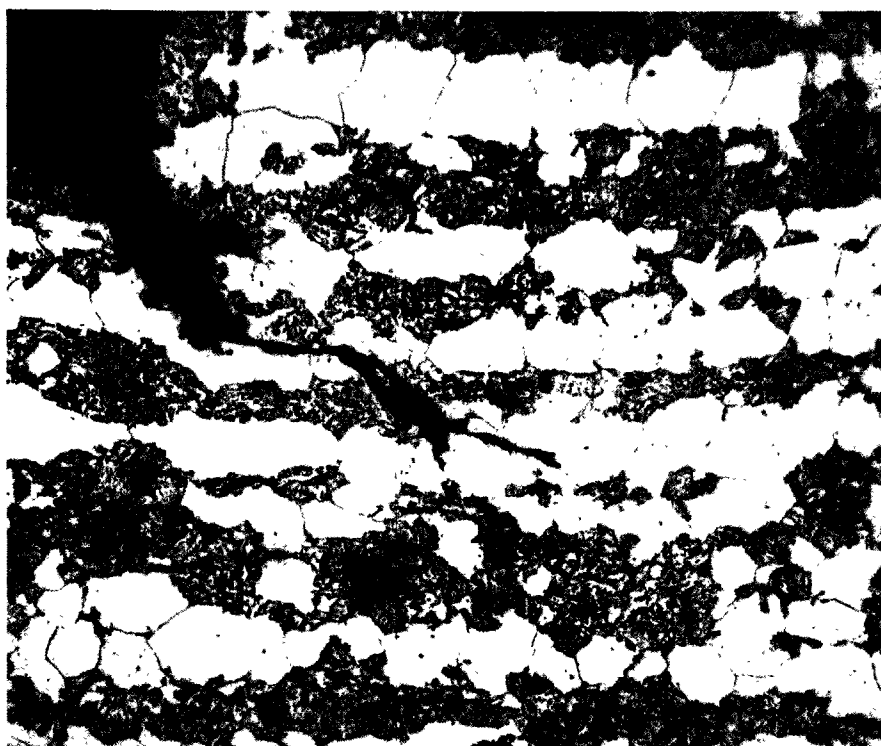
The sidewall tube failure is due to fatigue cracking that initiated from the toe of the attachment weld. The relatively straight, transgranular cracking with a few branches is characteristic of fatigue. The presence of high temperature oxide on the cracking near the OD surface indicates that the tube operated for some time with the cracking present prior to the failure event.

Figure 4. Views of the crack tip showing the transgranular nature of the crack propagation, indicating that while some slight corrosion was evident along the fracture surface, the cracking was driven by stress.

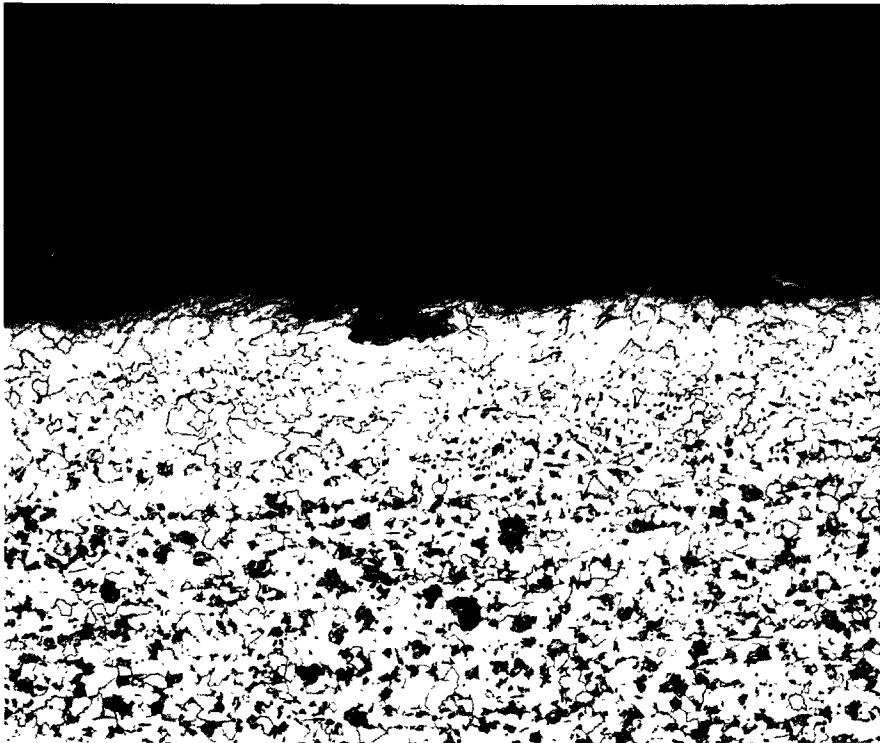
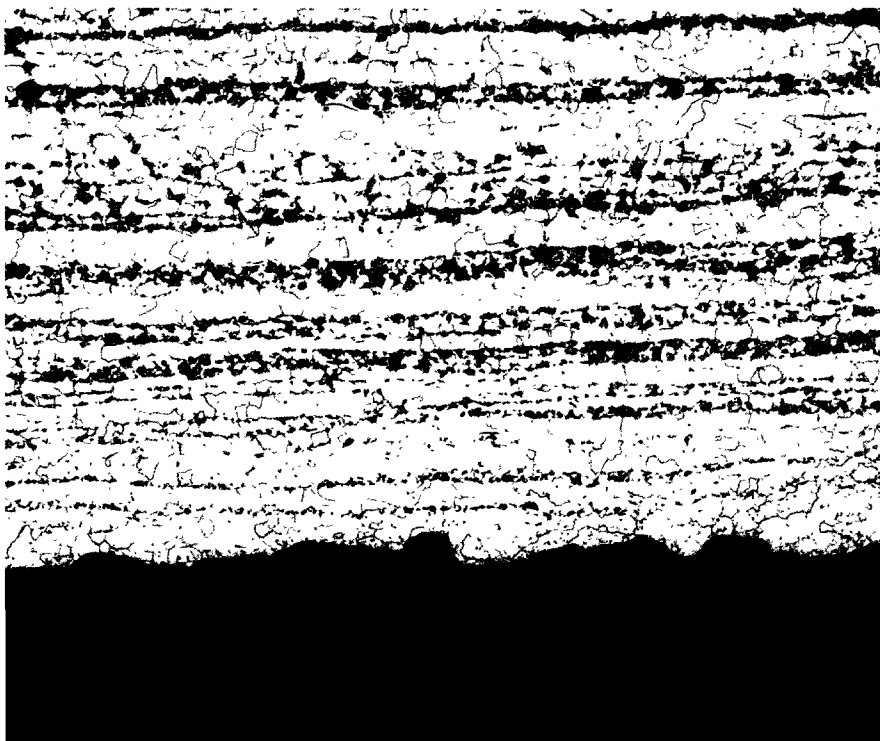
The high magnification examination of the external and internal surfaces of the tube section remote from the crack revealed minimal wastage, as shown in Figure 5. No evidence of cracks initiating from the internal surface was observed. Figure 6 shows the typical microstructure of the element away from the failure, which consists of pearlite in a ferrite matrix with nonmetallic inclusions scattered throughout. This microstructure is normal for carbon steel waterwall tubing, and showed no signs of overheating damage.

Figure 5. Typical views of the external and internal surfaces of the waterwall tube away from the failure. Note the presence of a decarburized layer on both surfaces, indicating that the tubing has not experienced significant wastage.

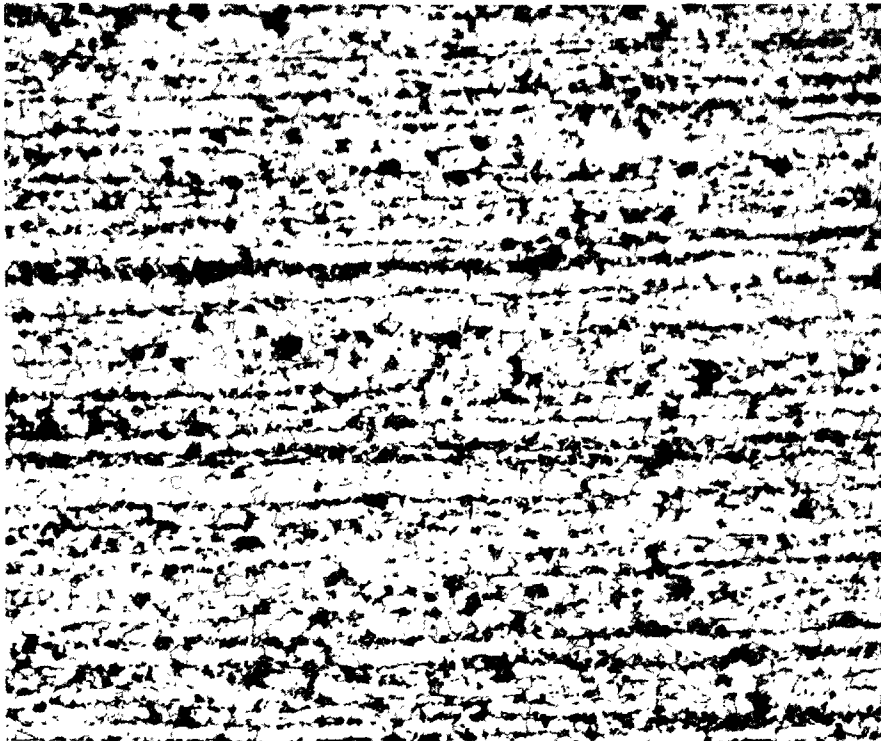
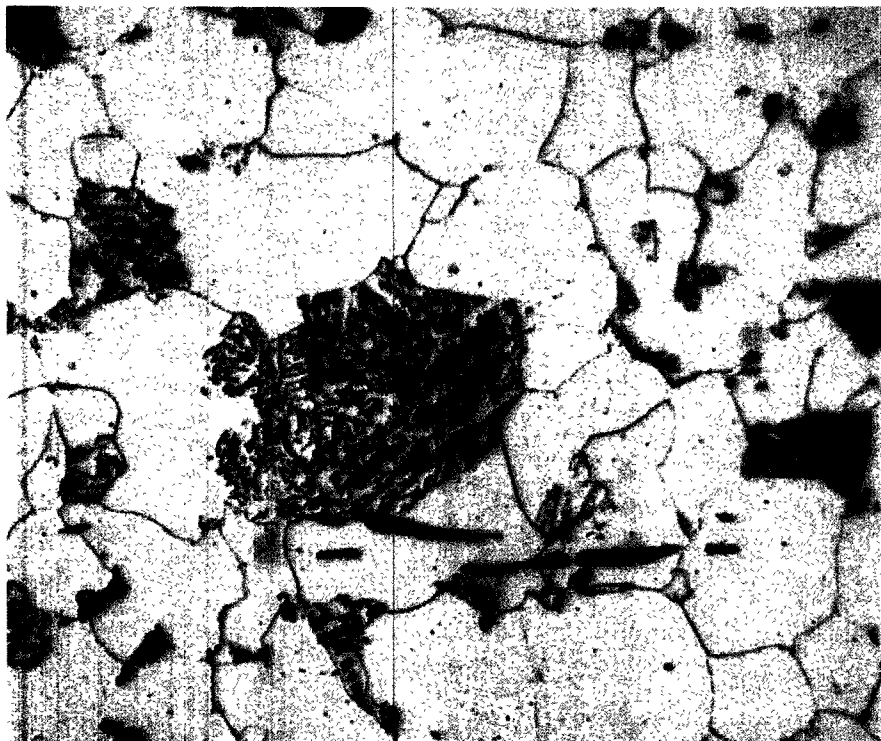
Figure 6. Typical views of the waterwall tube microstructure, which consists of intact pearlite colonies and ferrite grains. Some nonmetallic inclusions were scattered throughout the cross-section.
